*Barge Morris J. Berman Spill*  
**NOAA's Scientific Response**

HAZMAT Report 95-10  
September 1995

**Hazardous Materials Response and Assessment Division  
Office of Ocean Resources Conservation and Assessment  
National Oceanic and Atmospheric Administration**

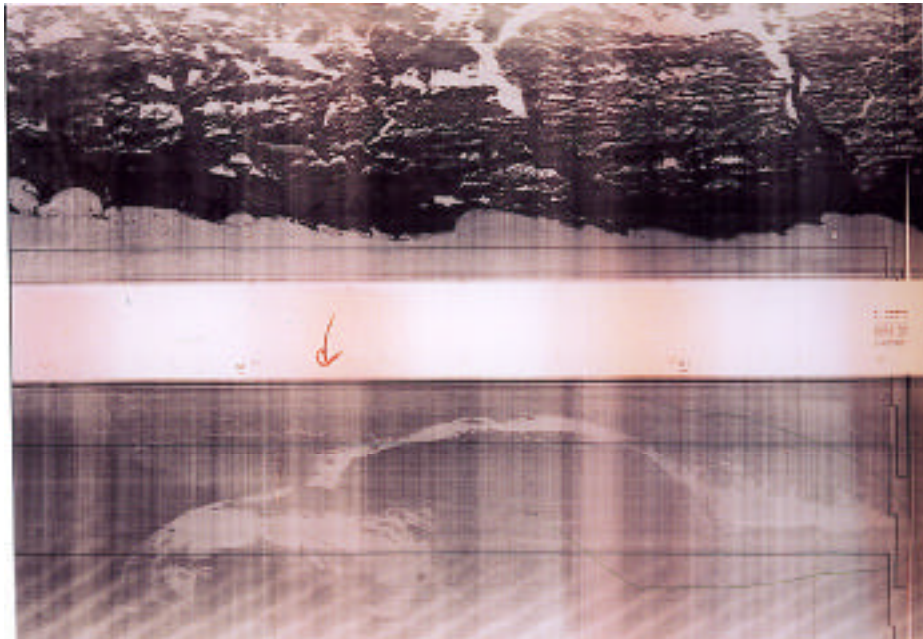
Figure 3. SLAR image for January 23, 1994. A large area of sheen containing widely scattered tarballs is visible as the lighter area shown in the upper half of the figure

On January 15, 1994, the leaking barge was refloated and towed to an offshore dump site where it was sunk with the remaining oil still aboard. Figure 3 is a SLAR image for January 23 showing a large tarball field west of the scuttling site. Briefing

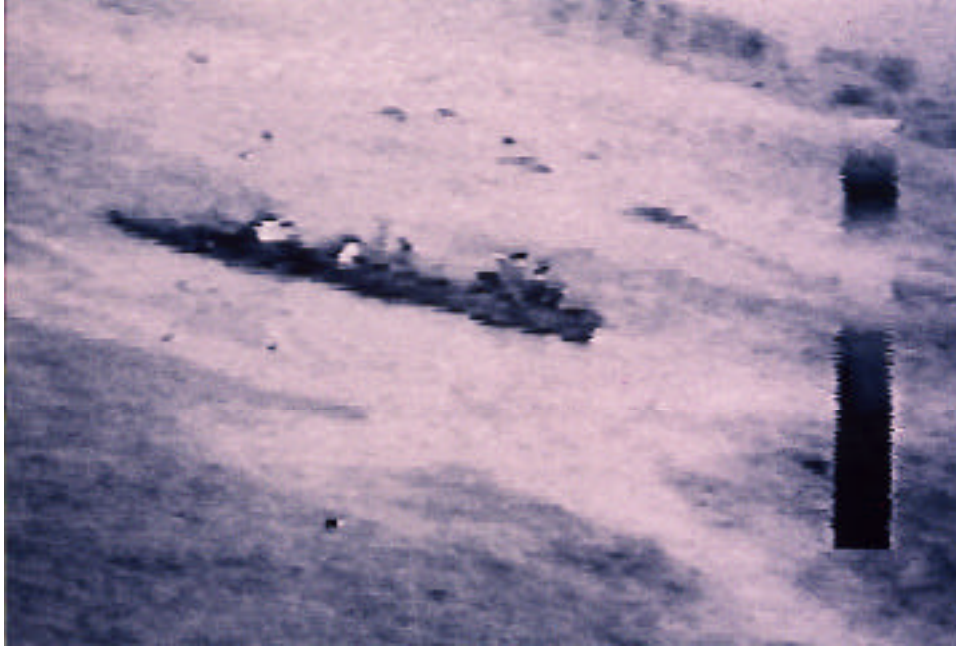
Figure 5. False-color IR image taken at night showing an oil slick surrounding the barge at the initial grounding site. Oil appears as the lighter portions of the figure but in this case it is difficult to distinguish from natural phenomena.

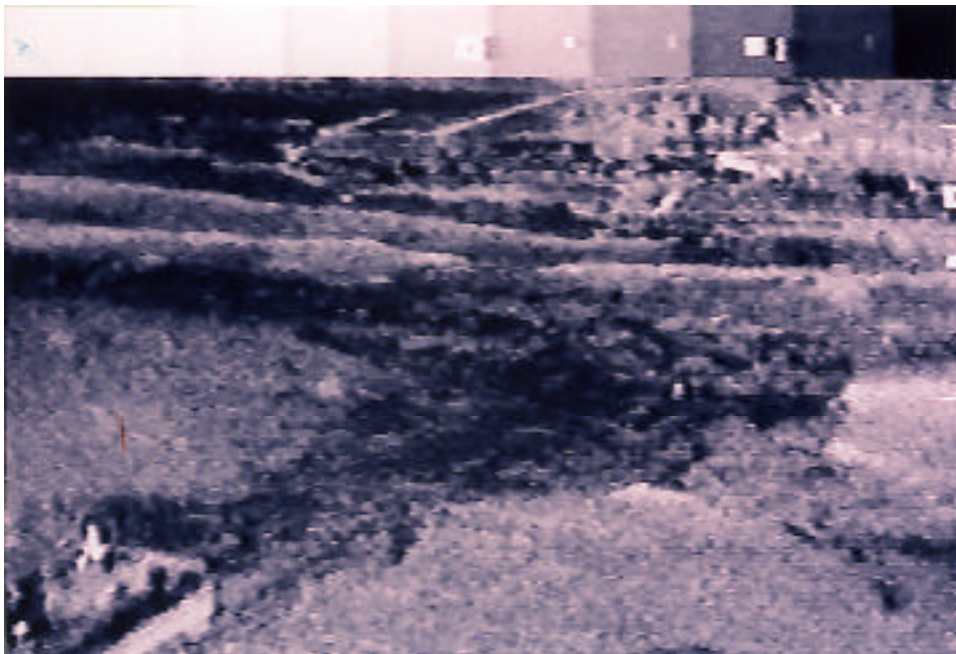
Figure 6. False-color IR image taken at night showing oil trailing from the barge (at the initial grounding site) to the beaches. Oil is shown in the center of the figure in the surf zone as the darker portions of the image, and at the top of the figure on the shoreline.

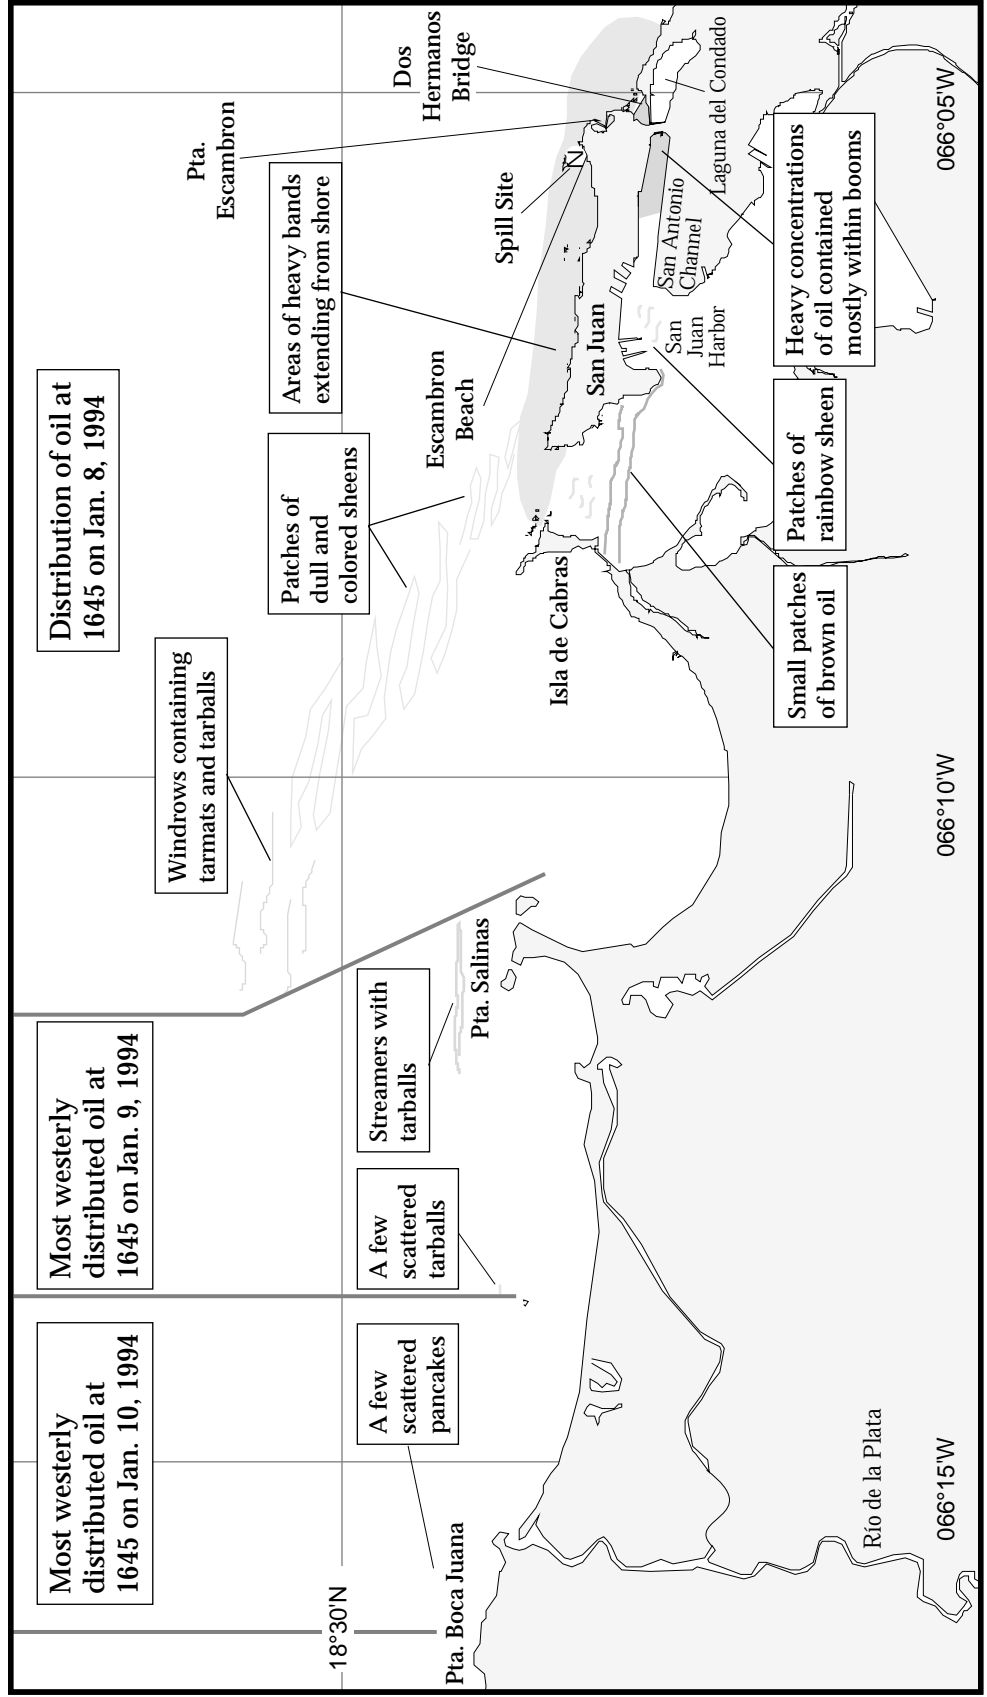
Figure 7. Oil distribution map.

The first overflights on January 8, 1994 show the oil impacting the eastern part of San Juan Island, Laguna del Condado, and the San Antonio channel with light sheen in the harbor area. Oil windrows trailed northwest from the accident site. Over the next few days, some of these windrows came ashore in the entrance of San Juan Harbor, Punta Salinas, and as far west as Punta Boca Juana, ten nautical miles away. The floating oil distribution remained almost in steady state while the barge continued to spill as it remained grounded at the original spill site. Oil would be found slightly to the east of the accident and as far west as Río de la Plata, with patches alternatively being next to shore or a few miles offshore depending on the local winds (Figure 7).

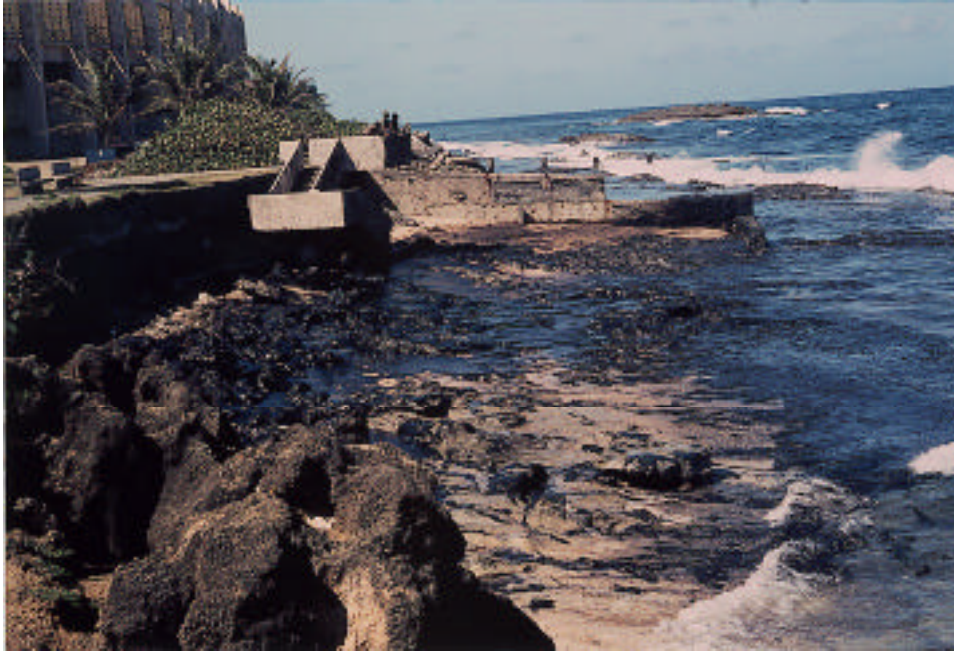
Figure 15A. Seawall and mixed sand and gravel beach at Escambron, San Juan, taken on January 10, 1994, looking west. The barge had grounded just north and east of this point. Oil came ashore continuously for over a week, until the barge was moved. Cleanup methods included vacuuming of floating oil, deployment of snare, manual removal, and high-pressure, hot-water washing of the seawall. Note the high wave energy of this site, indicated by the breaking waves.

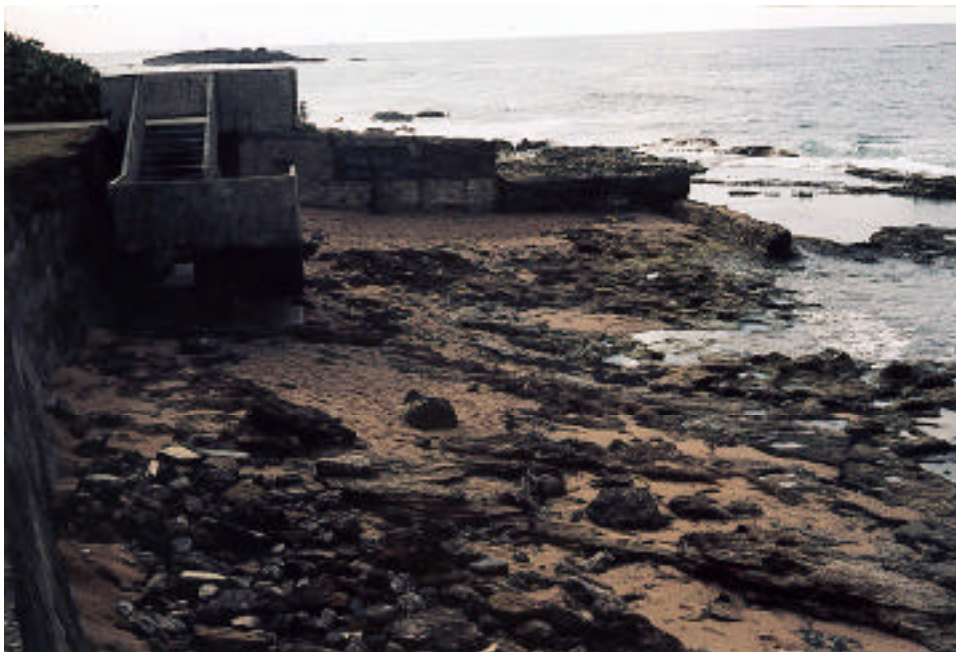
Figure 15B. Same site on May 10, 1994, after cleanup had been completed. No oil was visible either on the surface or with depth.

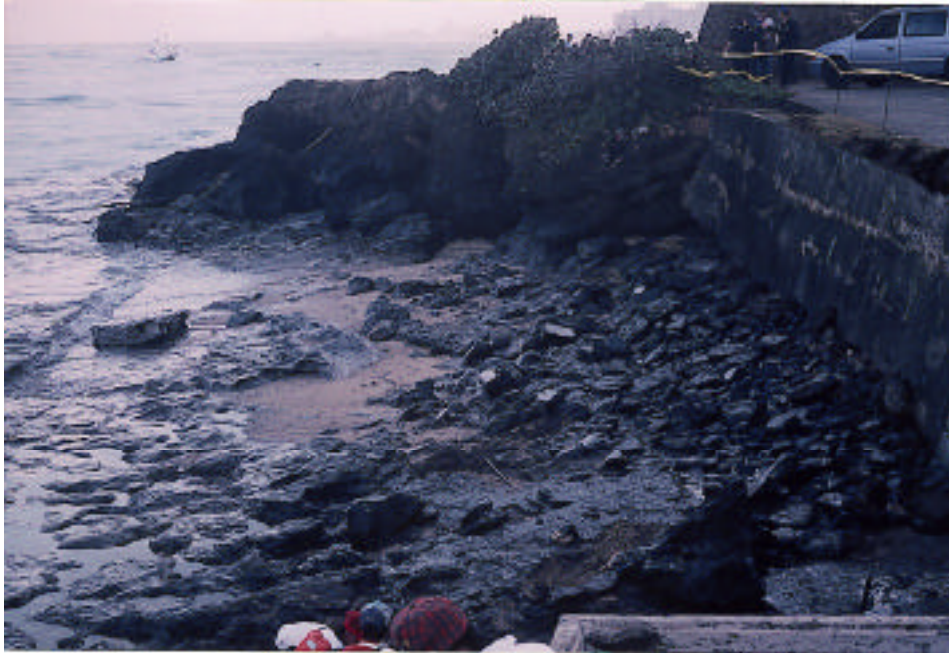
Figure 16A. Rocky shore, seawall, and mixed sand and gravel beach at Escambron, San Juan, taken on January 19, 1994 looking east from the stairs shown in Figure 15A. The heavy oil had coated much of the intertidal zone.

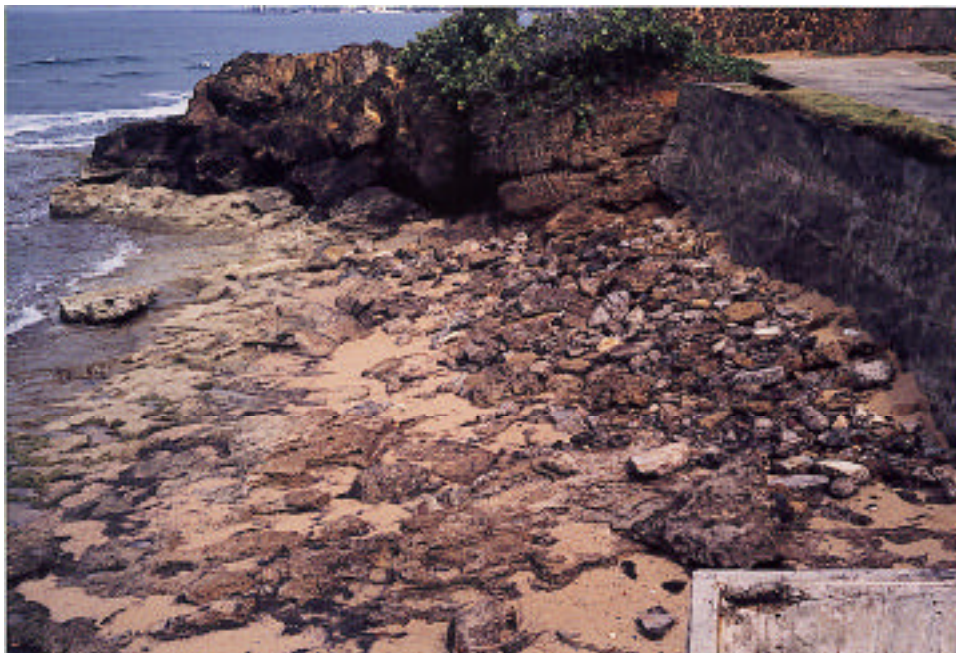
Figure 16B. Same site on May 10, 1994, after cleanup had been completed. The only visible oil was staining on the sides of the rocky outcrops of beachrock, which was not cleaned with high-pressure washing because of the friable nature of the beachrock.

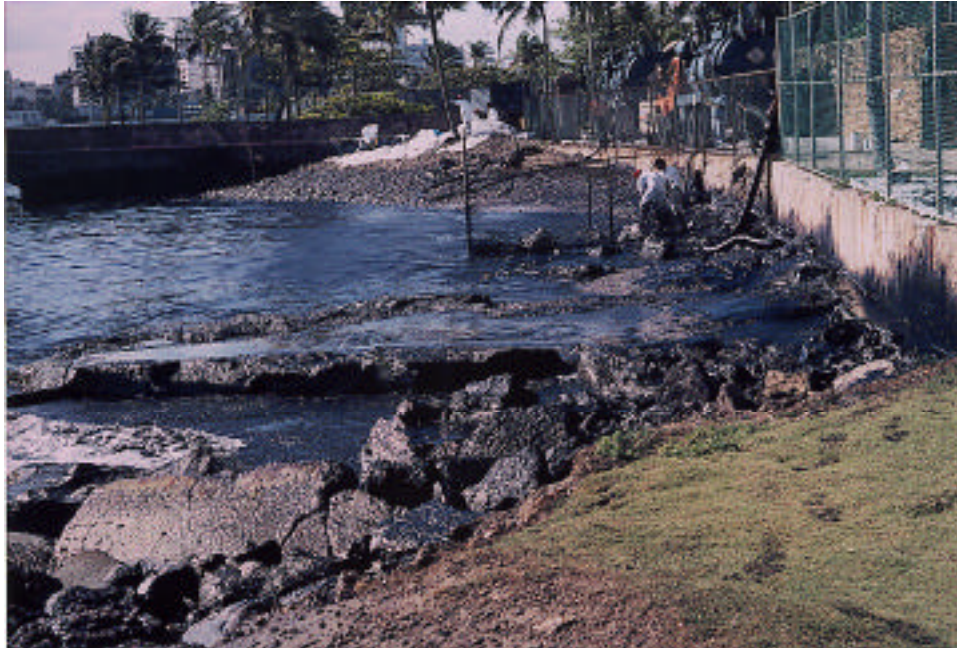
Figure 17A. Mixed sand and gravel beach just north of Fort San Geronimo, San Juan, taken on January 10, 1994. This site was a natural accumulation area formed by the bridge to the fort. Large amounts of heavy oil had penetrated the beach sediments.

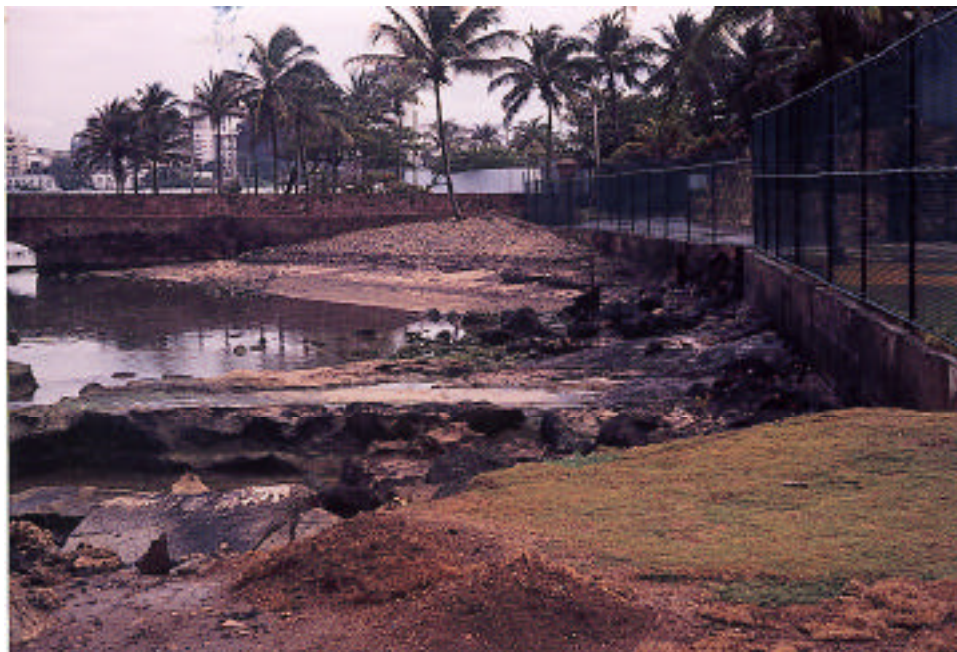
Figure 17B. Same site on May 10, 1994, after cleanup had been completed. The surface sediments were clean, but a layer of lightly oiled sediments remained at 15-20 cm below the surface.

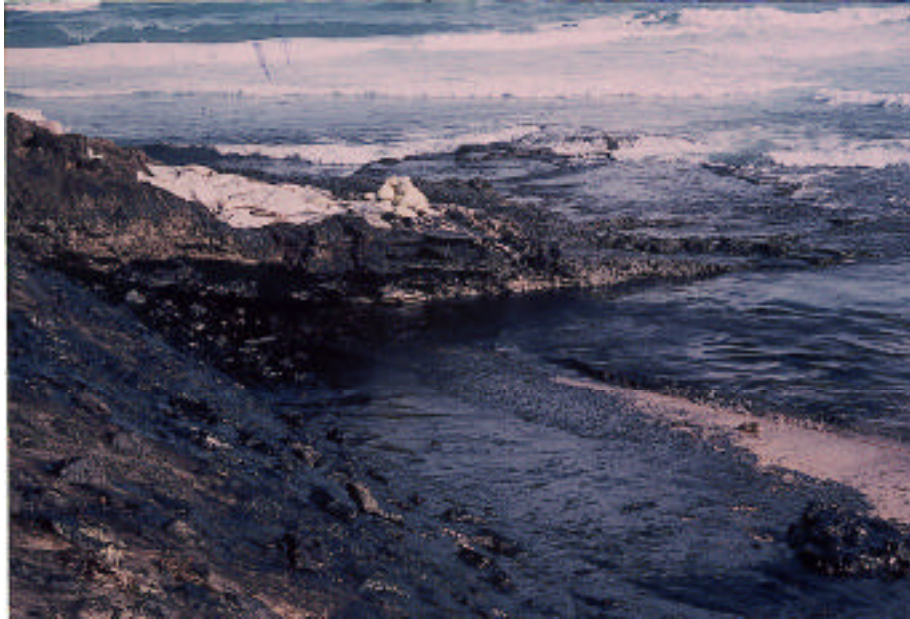
Figure 18A. Seawall and sand beach directly in front of Punta Escambron, San Juan, taken on January 18, 1994. The barge had grounded just offshore of this point. The beachrock ledge in the background was the site of the test of shoreline cleaning agents. Free-floating oil accumulated in the lee of the beachrock, and oil was recovered with vacuum and snares for several weeks. The seawall was cleaned with high-pressure, hot-water washing. The viscous oil did not penetrate or adhere well to the sandy beach sediments.

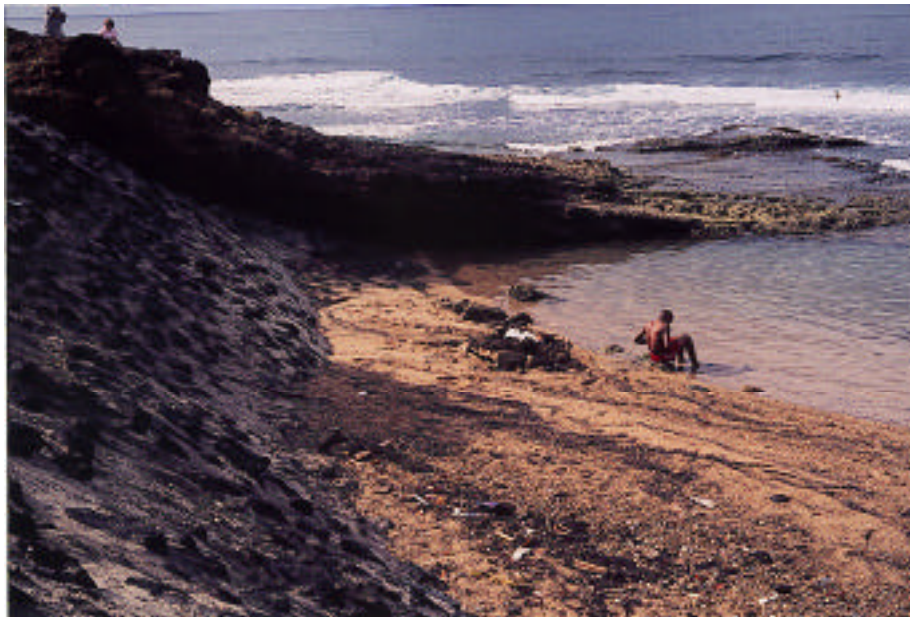
Figure 18B. Same site, taken on May 10, 1994, after cleanup had been completed. There was no visible oil on the seawall or sediments. Note the recreational use of the shoreline.

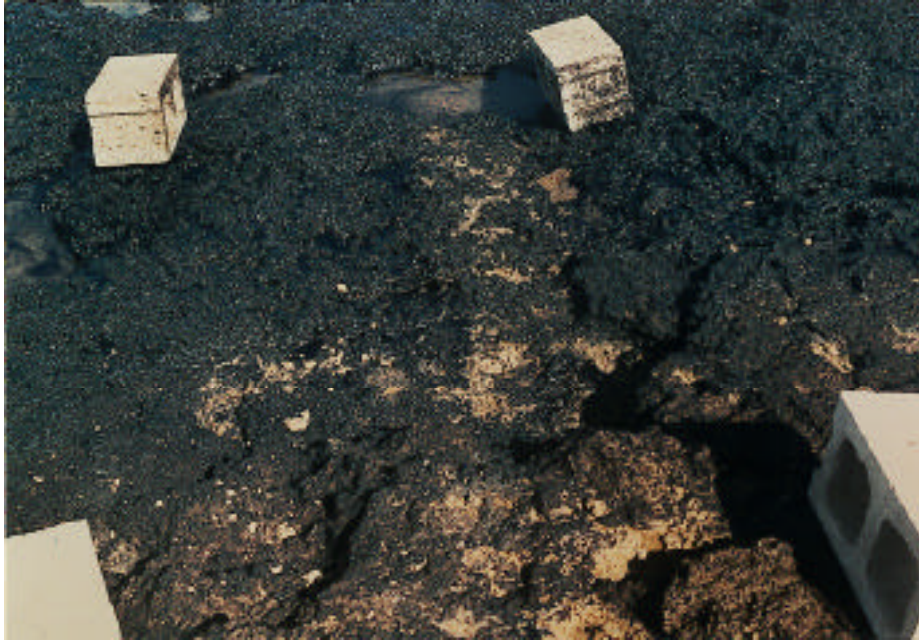
Figure 20A. Plot for high-pressure, hot-water washing alone. The concrete blocks define the corners of the test plot. On the left, washing was conducted with water up to 500 psi and 140°F. Note that very little oil was removed. On the right, washing was conducted with water up to 1,000 psi and 175°F. At this pressure, parts of the rock began to chip off.

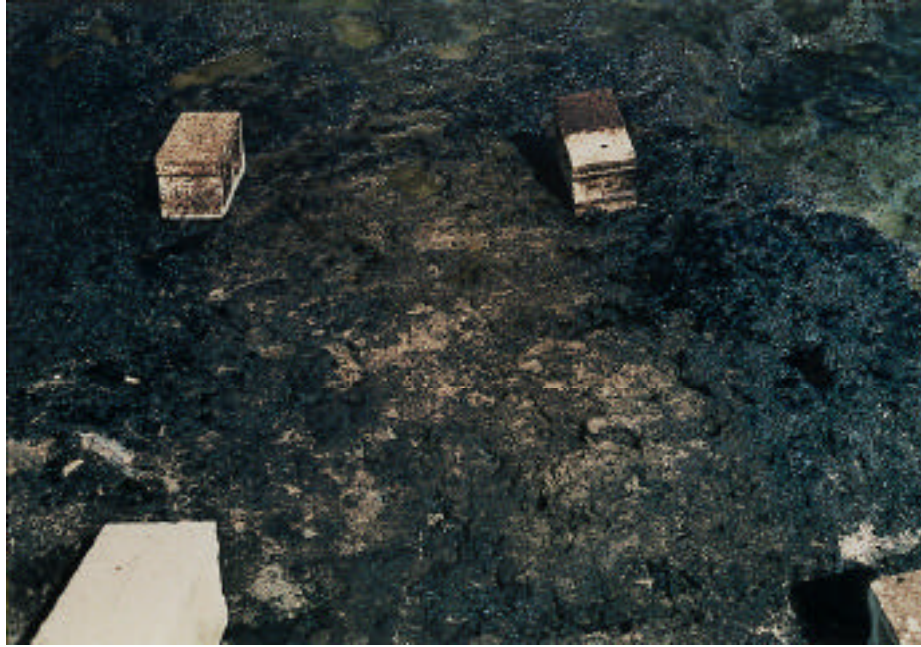
Figure 20C. Plot for the Corexit 9580 cleaner, which was flushed with high-pressure, hot water: the left side of the plot at 500 psi and 140°F; the right side at 1,000 psi and 175°F. The right side was significantly cleaner without any chipping of rock. The worker tended to sweep the entire area with the spray because oil was continually released during washing.

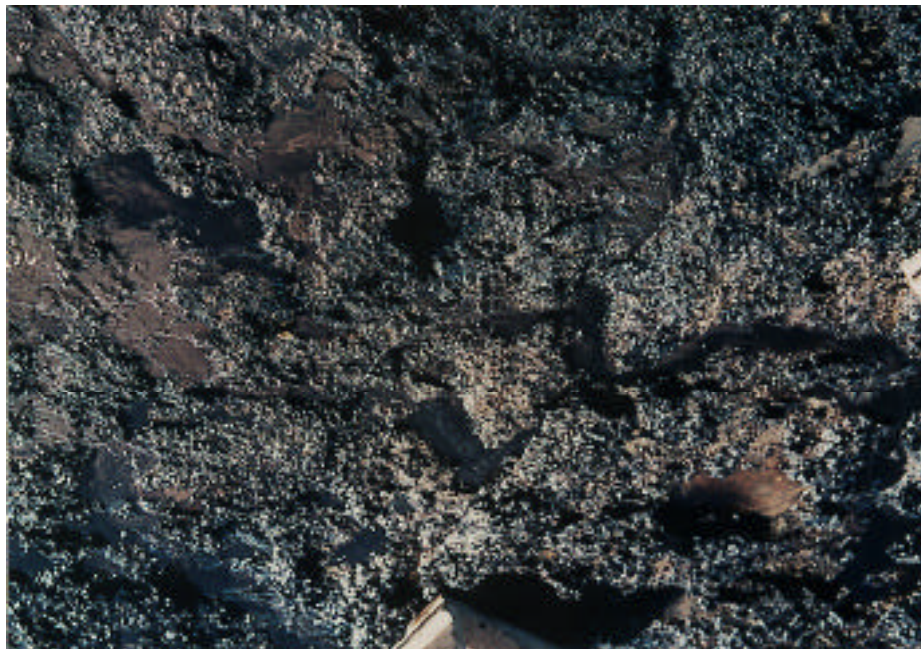
Figure 20D. Close-up of the Corexit 9580-treated beachrock surface during flushing operations. Note that some of the oil has dispersed, forming brown, muddy wash water in addition to black oil.

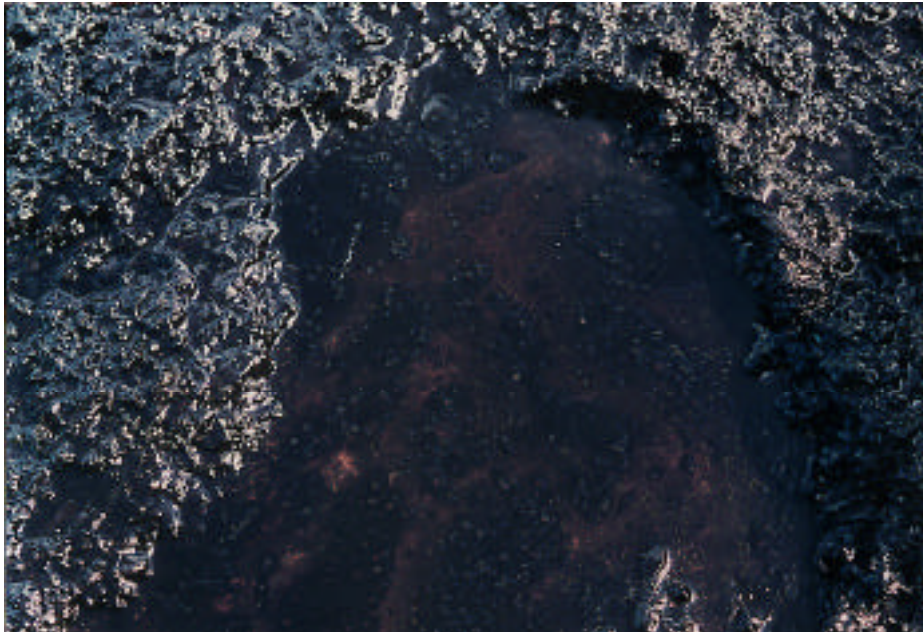
Figure 20F. Close-up of the PES-51-treated beachrock surface during flushing operations. None of the oil was dispersed, even at 1,000-psi water pressures. Treated and released oil was liquid and black, with small bubbles attached to floating slicks.

substrate, which removed some beachrock. There was no dispersion of the treated oil; the runoff water was clear and the released oil remained black and recoverable (Figure 20F).

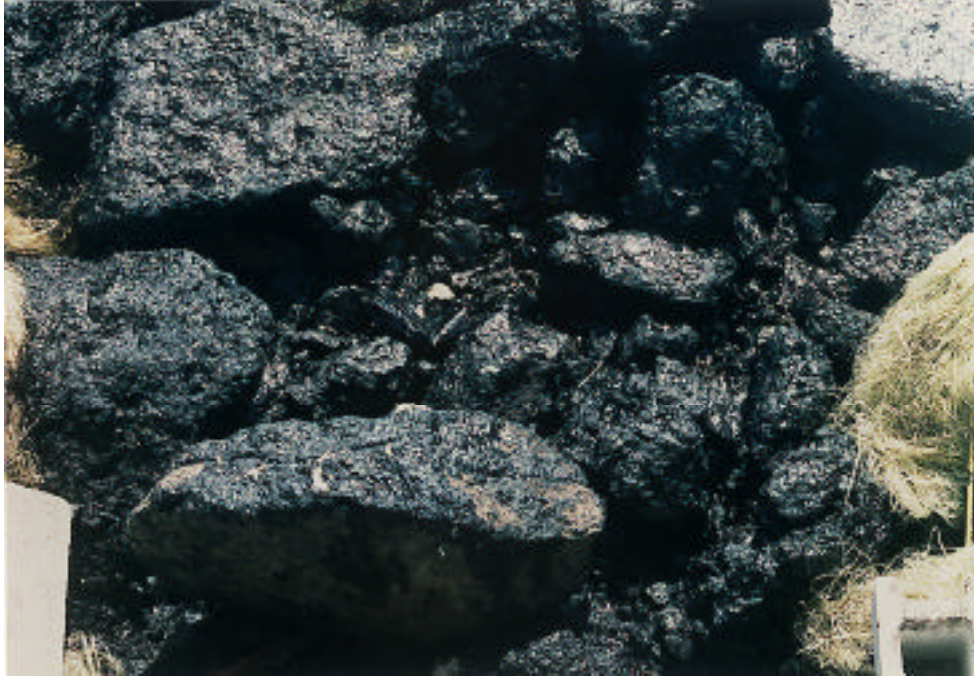
Figure 21A. The rip rap washing test reference plot. No pressure washing of any kind was conducted. All the plots had been cleaned to the extent possible by manual wiping.

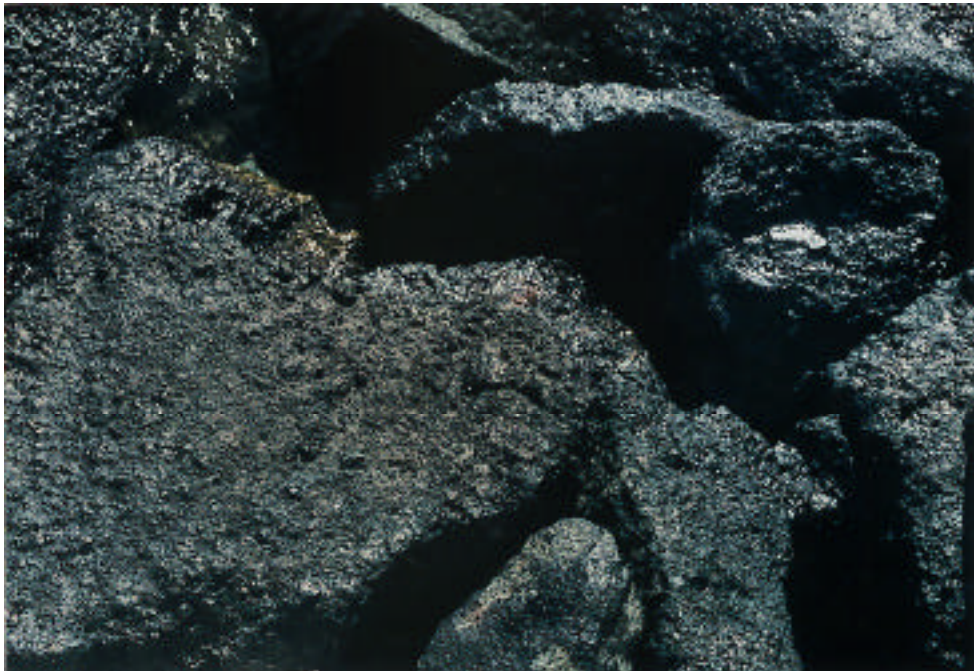
Figure 21B. Plot for high-pressure, hot-water washing alone on rip rap. Pressure and temperature were incrementally increased to 1,200 psi and 175°F. Smooth rock surfaces were cleaned much better than the rough surfaces.

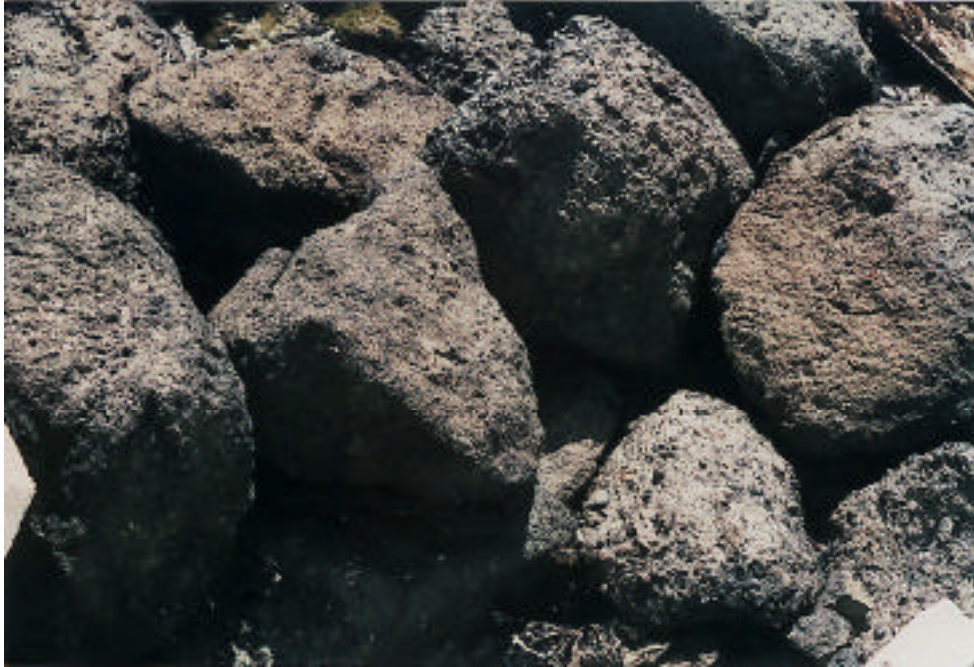
Figure 21C. Plot for the Corexit 9580 cleaner on rip rap; washing was conducted up to 1,200 psi and 175°F water.

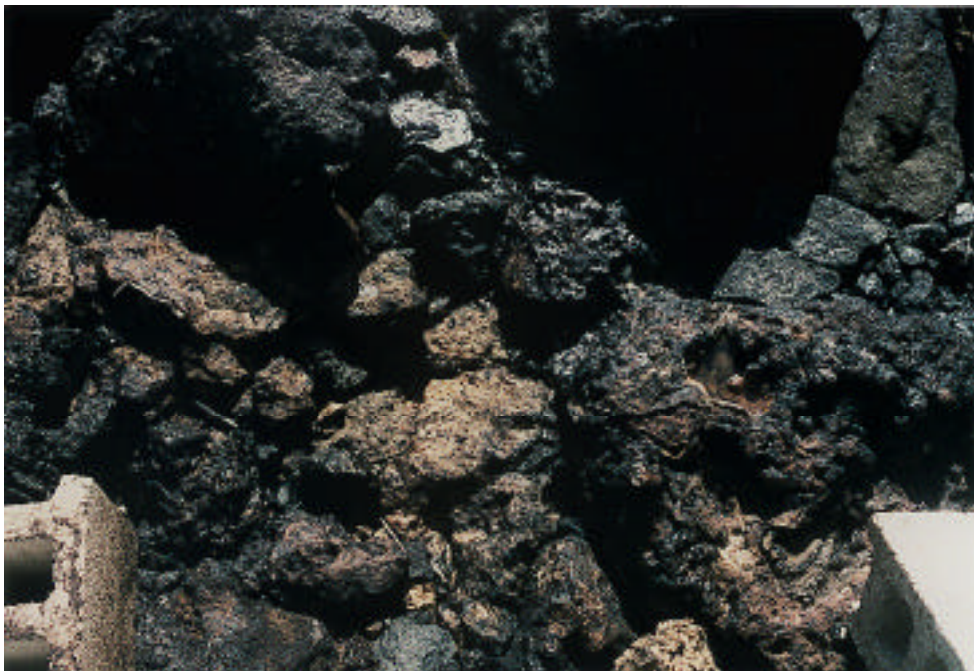
Figure 21D. Plot for the PES-51 cleaner on rip rap with ambient-water-flushing at 1,200 psi.

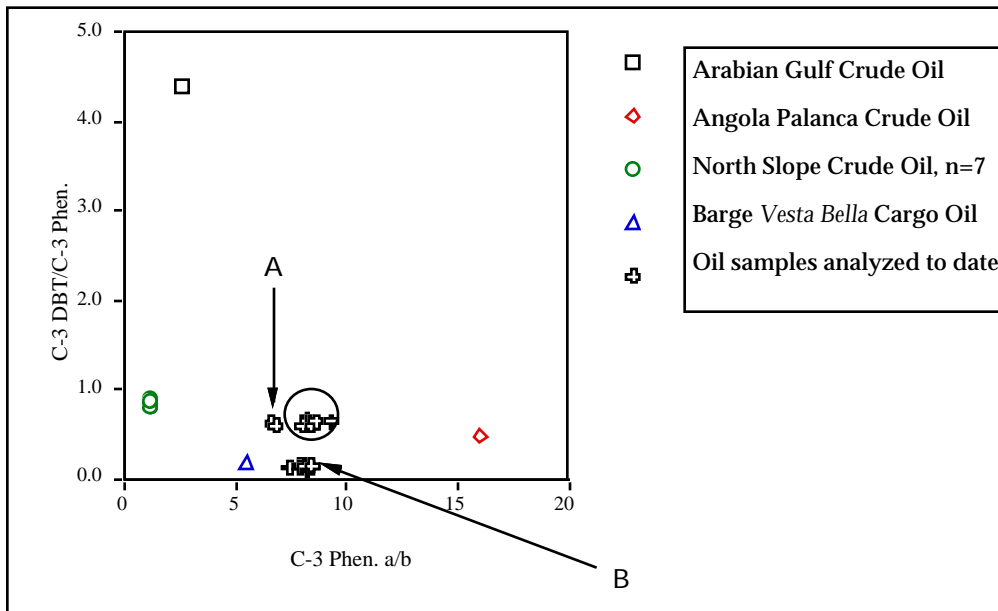
Figure 23. SFI plot of selected crude oils, the reference oil from the Barge *Vesta Bella* and samples analyzed from the *Berman* incident. The circle indicates the target range of SFI values for oils sourced from the *Berman*. Samples indicated by arrows A and B are non-matches to the *Berman* reference oils. The cluster of samples indicated by arrow B may actually represent two “mystery” sources.

total of 12 times. The results indicated by arrow A are for duplicate analyses of the sample submitted from Isla Culebrita. Initially, this sample was reported as a positive match. However, after reevaluation and analysis of a larger data set, this sample scored as a non-match (although there is a strong correlation between the oils, it is not the same oil loaded on the *Berman*). Samples indicated by arrow B represent the non-match samples submitted and identified as St. Johns Island; Culebra, Flamenco Beach; and Segment 15 and Zone 17 (Punta Cerro Gordo to Isabella). The cluster of samples identified by arrow B may actually represent two “mystery” sources.
