**Draft  
Phase I Environmental Site Assessment**

**District of Columbia Properties  
Poplar Point, Washington, DC**

Prepared by  
Ridolfi Engineers Inc.

May 17, 2002

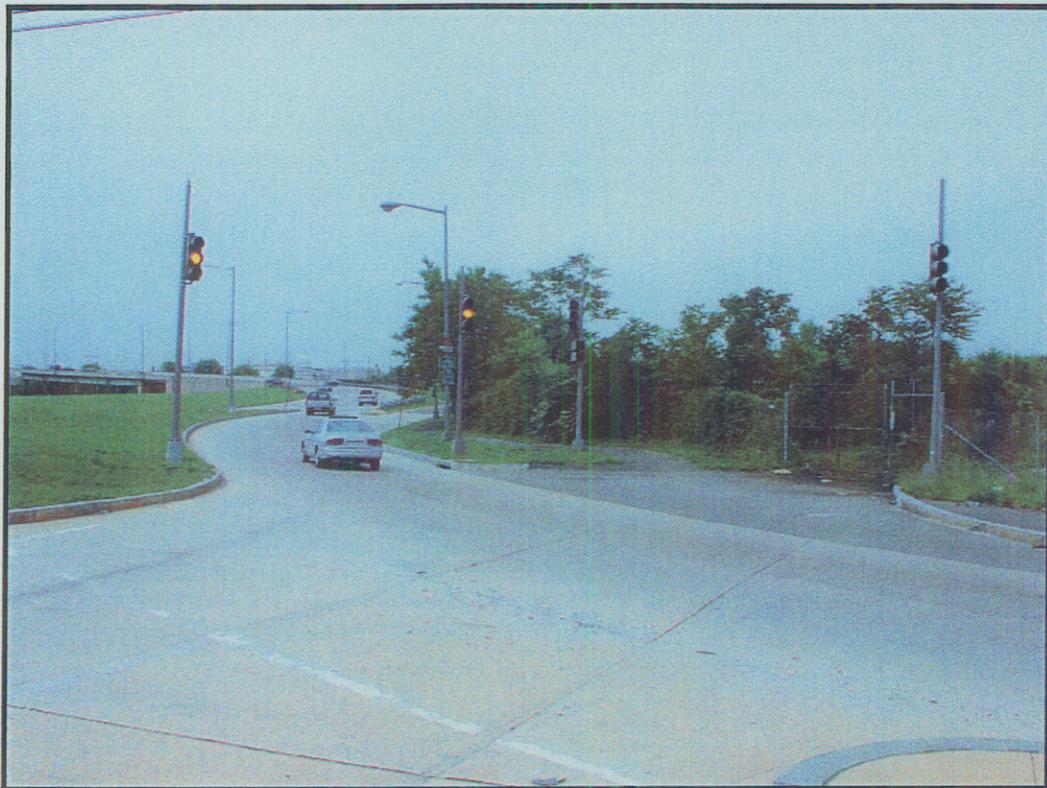
**Photo 1:** Overview of southern portions of 5860-960 and 5860-938, facing north. Note: Frederick Douglas Memorial Bridge on left side of photograph.

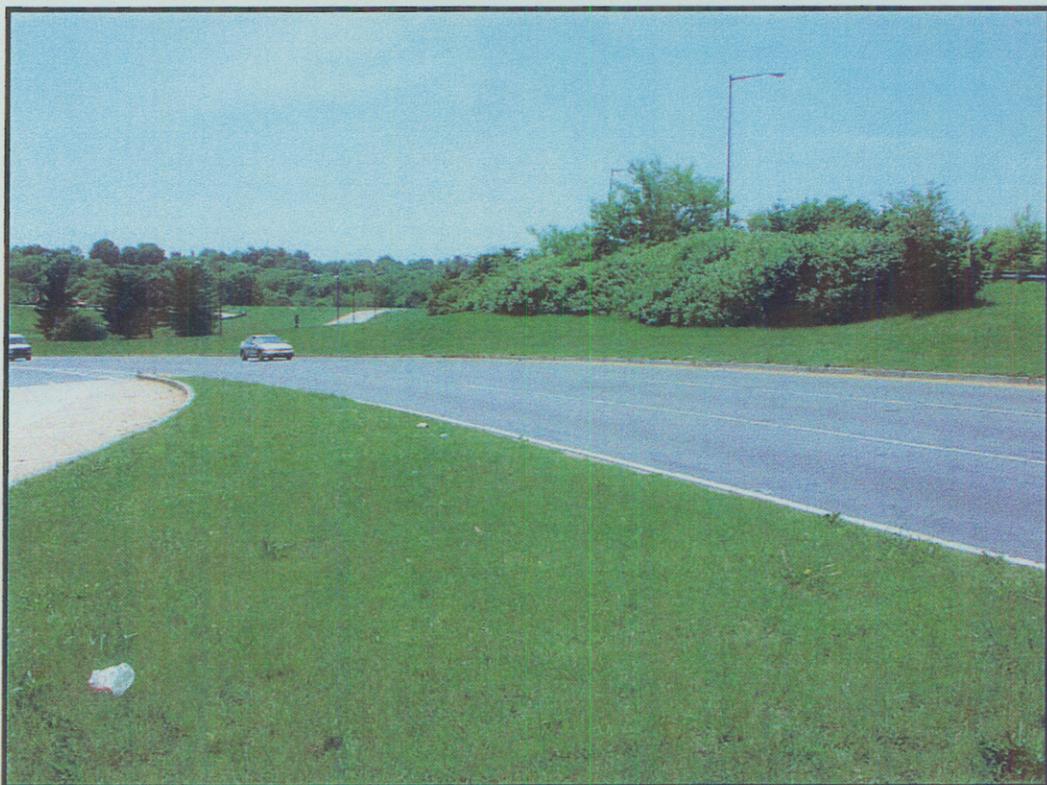
**Photo 2:** Overview of northern portions of 5861-942, 5861-943, 5861-944, and 5861-945, facing southwest. Note: Suitland Parkway on central portion of photograph.

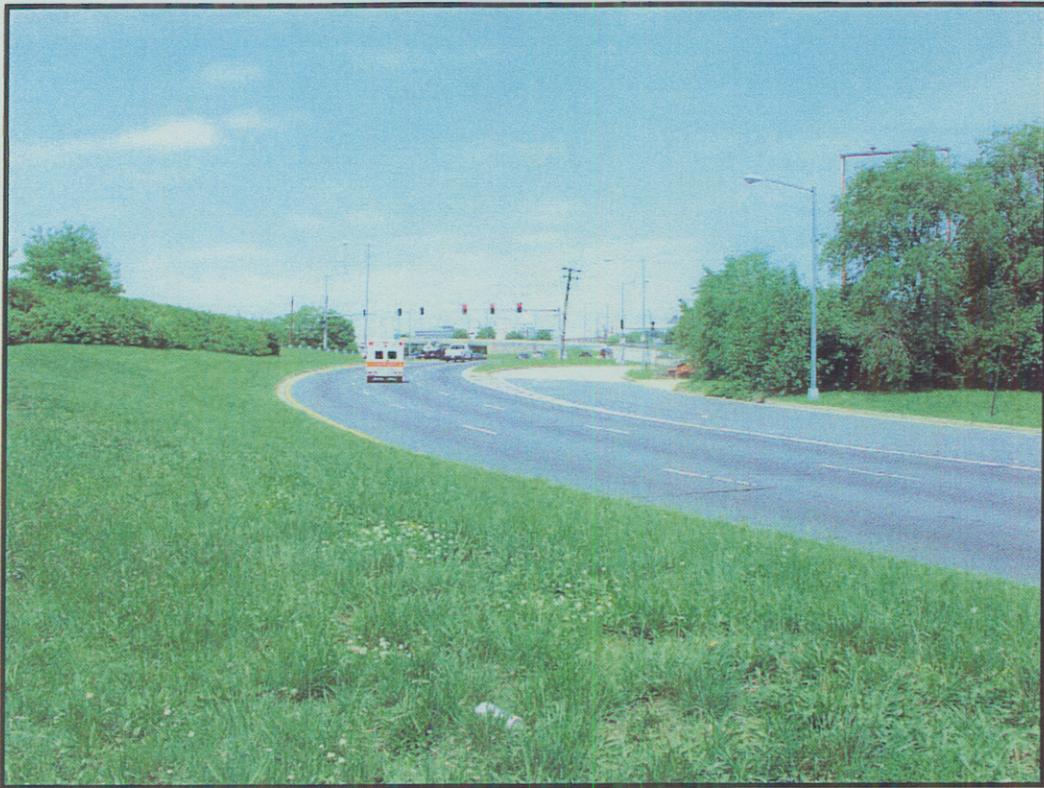
**Photo 3:** Overview of the southern portions of 5861-942, 5861-943, 5861-944, and 5861-945, facing northeast. Note: Suitland Parkway in central portion of photograph.

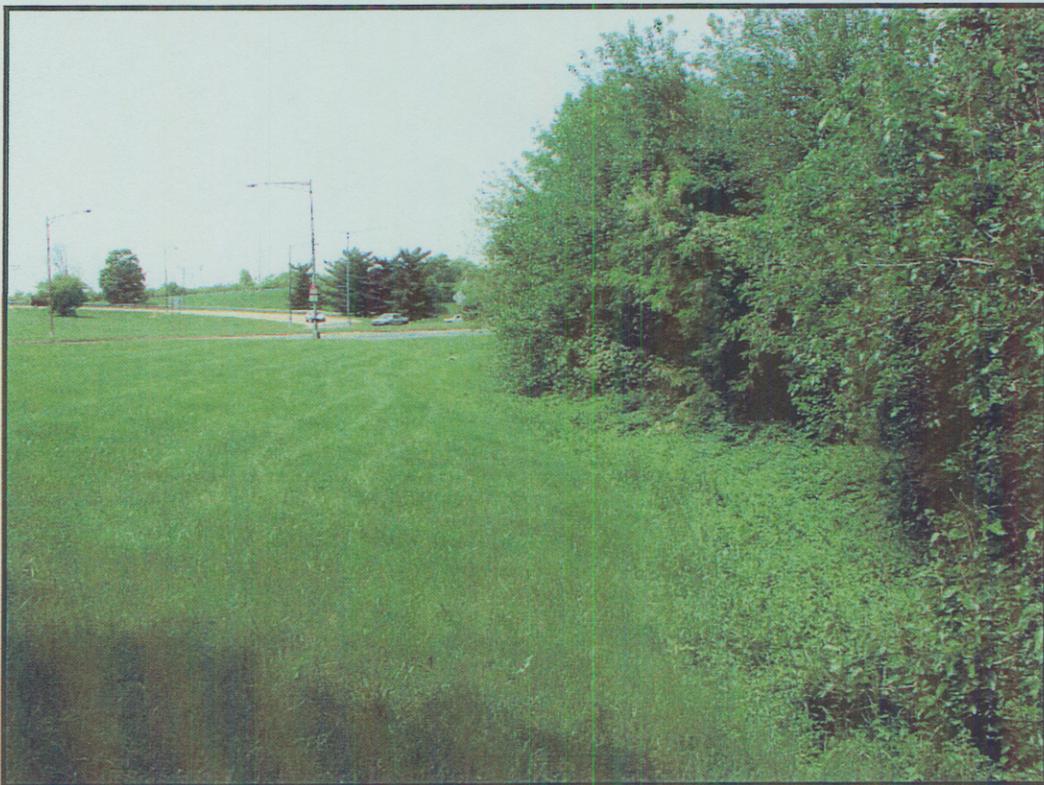
**Photo 4:** Overview 5861-956, 5861-954, and 5861-952, facing east.

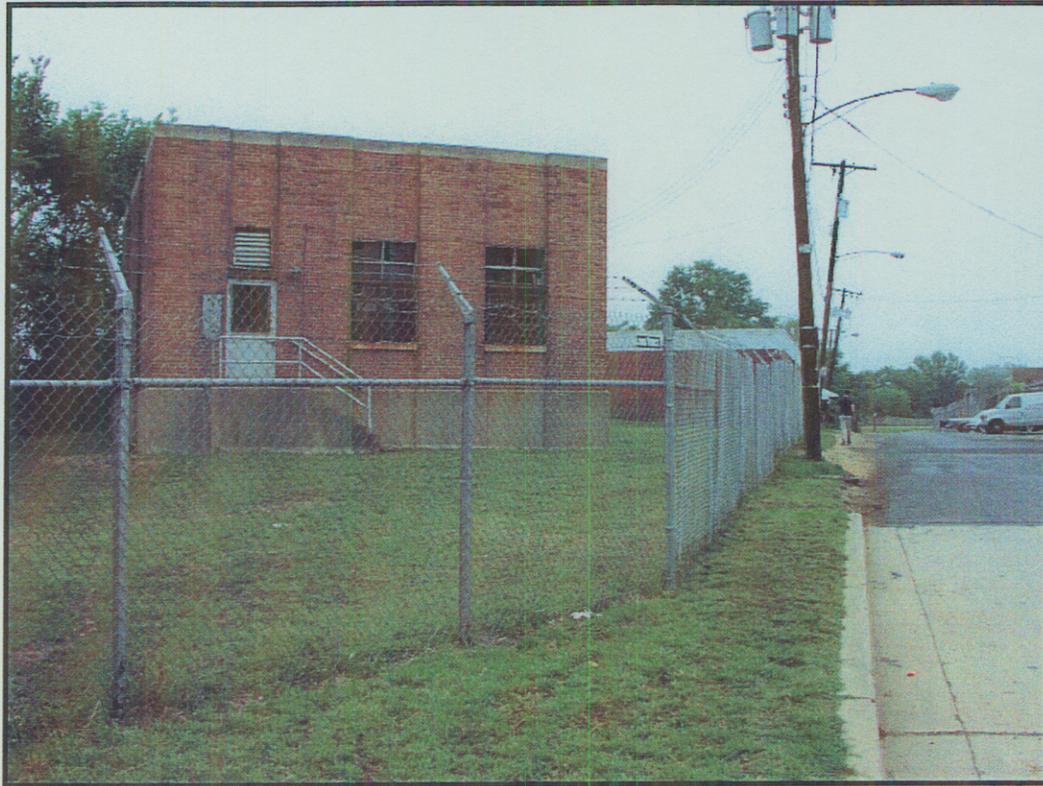
**Photo 5:** Overview of 5864-808, facing northeast. Note: pole mounted transformers on top right portion of photograph.

Three pole mounted electrical transformers were observed near the northern portion of 5864-808. No signs of staining were observed on the transformers or on the ground surface below the transformers. The transformers did not appear to represent RECs in connection with the Project Study Area.

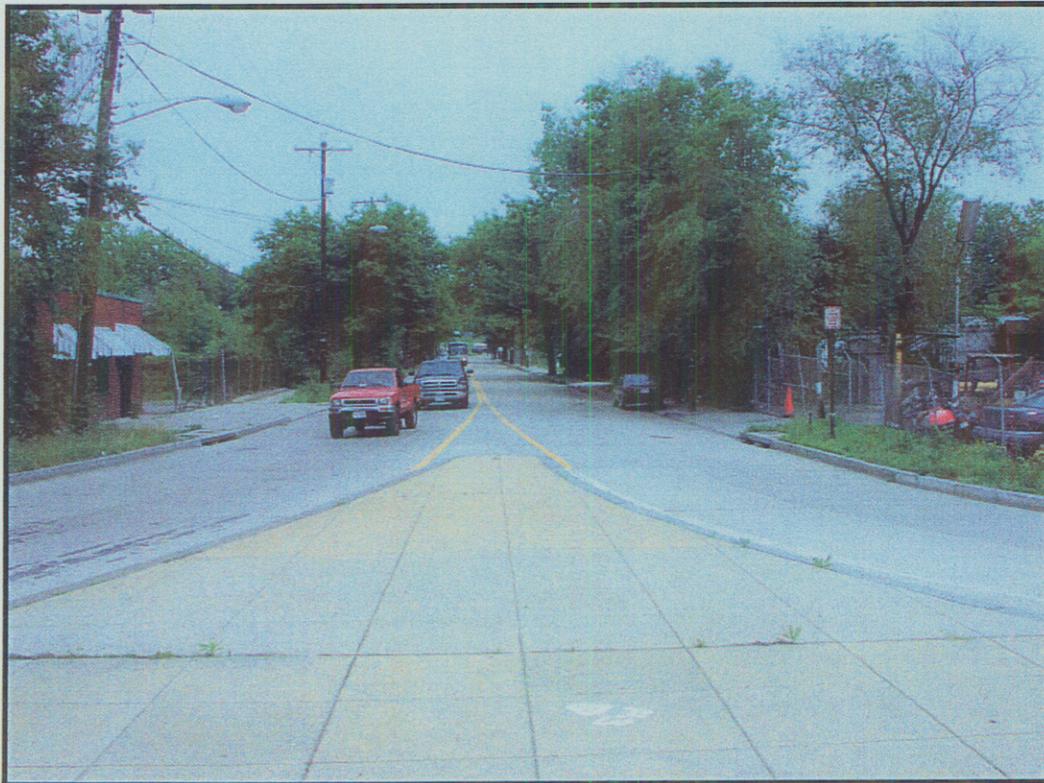
**Photo 6:** View down Howard Road S.E. from Suitland Parkway, facing southeast. Note: Green Fuel Oil, Inc. on left side of photograph and automobile scrap yard on right side of photograph.

Green Fuel Oil Inc. is located approximately 140 feet east of 5860-938. Five above ground storage tanks (ASTs) and several fuel trucks were observed on the Green Fuel Oil Inc. property. Staining was observed on the one of the ASTs and on the ground surface beneath the AST. The ASTs, staining, and fuel trucks observed on the Green Fuel Oil Inc. property appeared to represent a REC in connection with the Project Study Area.

An automobile scrap yard and a trailer storage yard adjoin 5861-943, 5861-942, and 5861-950 to the northeast. Several scrap automobiles, automobile parts, and debris were observed on the automobile scrap yard property. Staining was observed on the ground surface near some of the debris located on the scrap yard property. The staining and scrap automobiles represented a REC in connection with the Project Study Area.

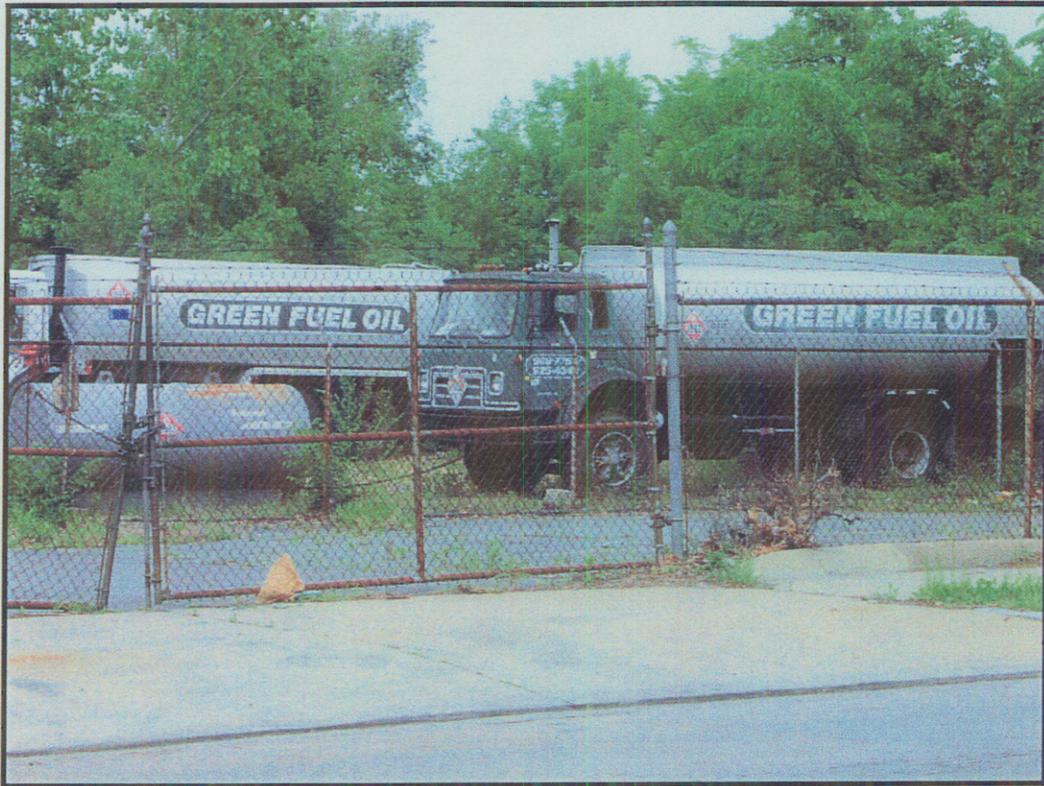
**Photo 7:** Fuel trucks located on southern portion of Green Fuel Oil, Inc. property, facing northeast. Note: diesel fuel AST on left side of photograph.

At the time of Ridolfi's observational walkover no evidence of underground storage tanks (USTs), such as vent and fill pipes and concrete pads, were observed on the Properties. Five ASTs and several fuel trucks were observed on the Green Fuel Oil Inc. property located approximately 140 feet east of Property 5860-938. The five ASTs consisted of two diesel fuel ASTs, one kerosene AST, one Duralane AST, and one gasoline AST. Staining was observed on the Duralane AST and on the ground surface beneath the AST. The ASTs, staining, and fuel trucks observed on the Green Fuel Oil Inc. property appeared to represent a REC in connection with the Project Study Area.

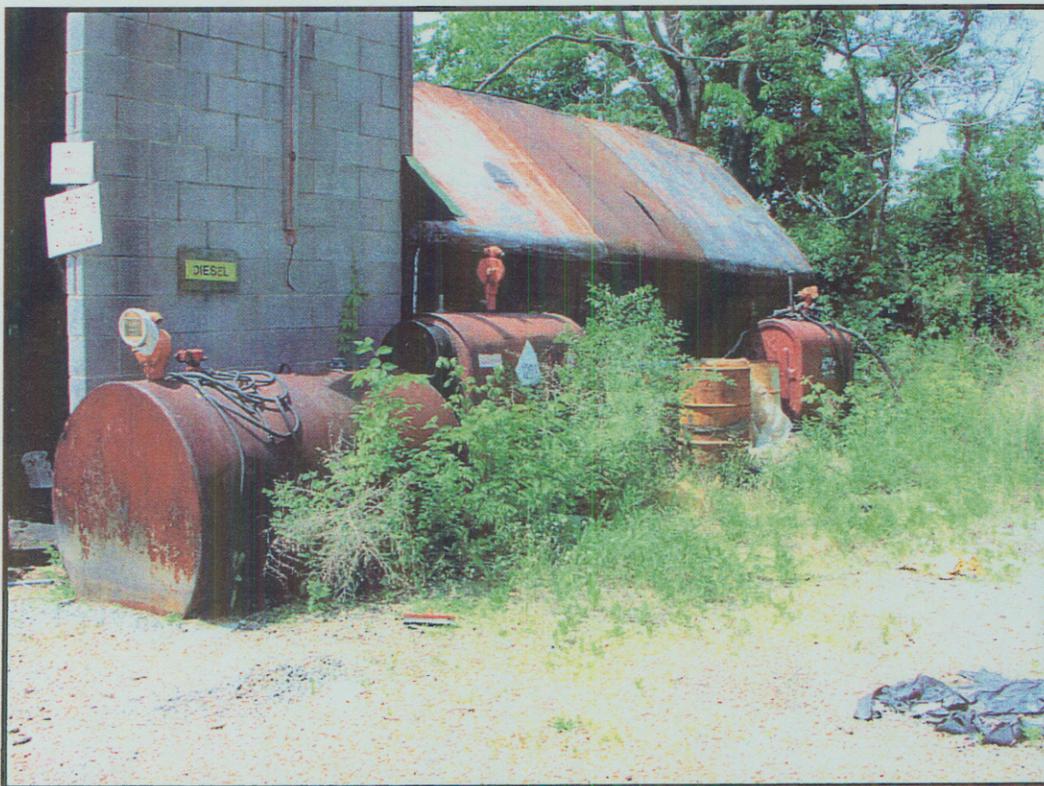
**Photo 8:** ASTs located near central portion of Green Fuel Oil, Inc. property, facing southwest.

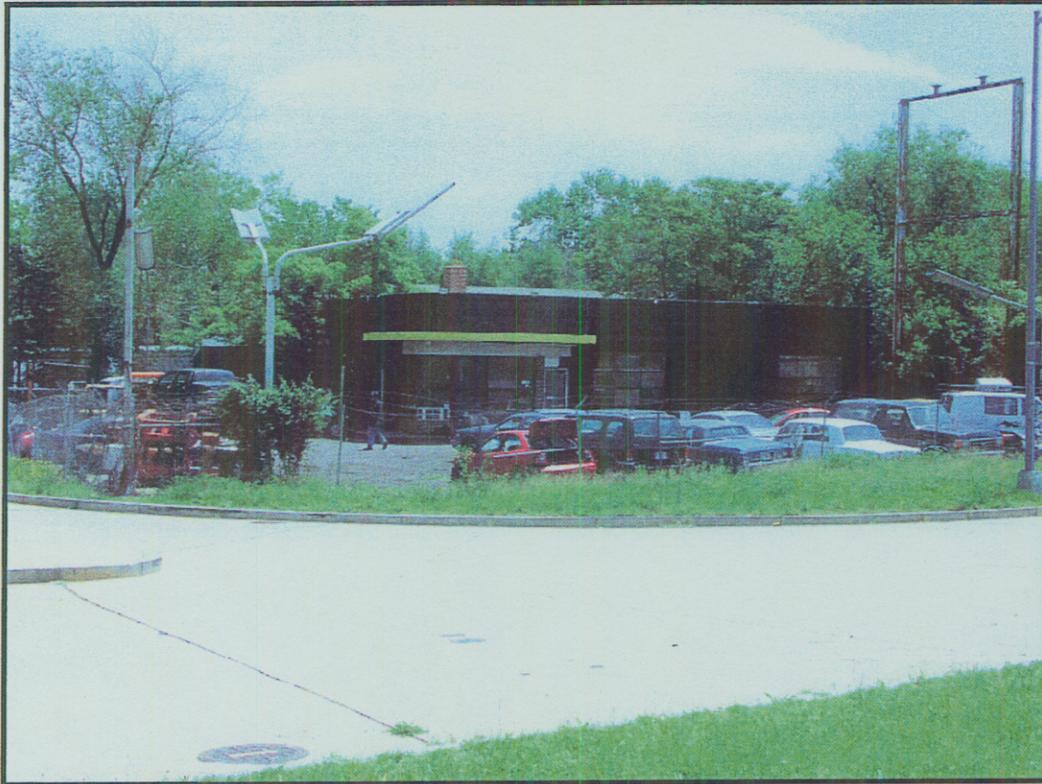
**Photo 9:** Overview of automobile scrap yard located near southeast corner of Howard Road S.E. and Suitland Parkway, facing southeast.

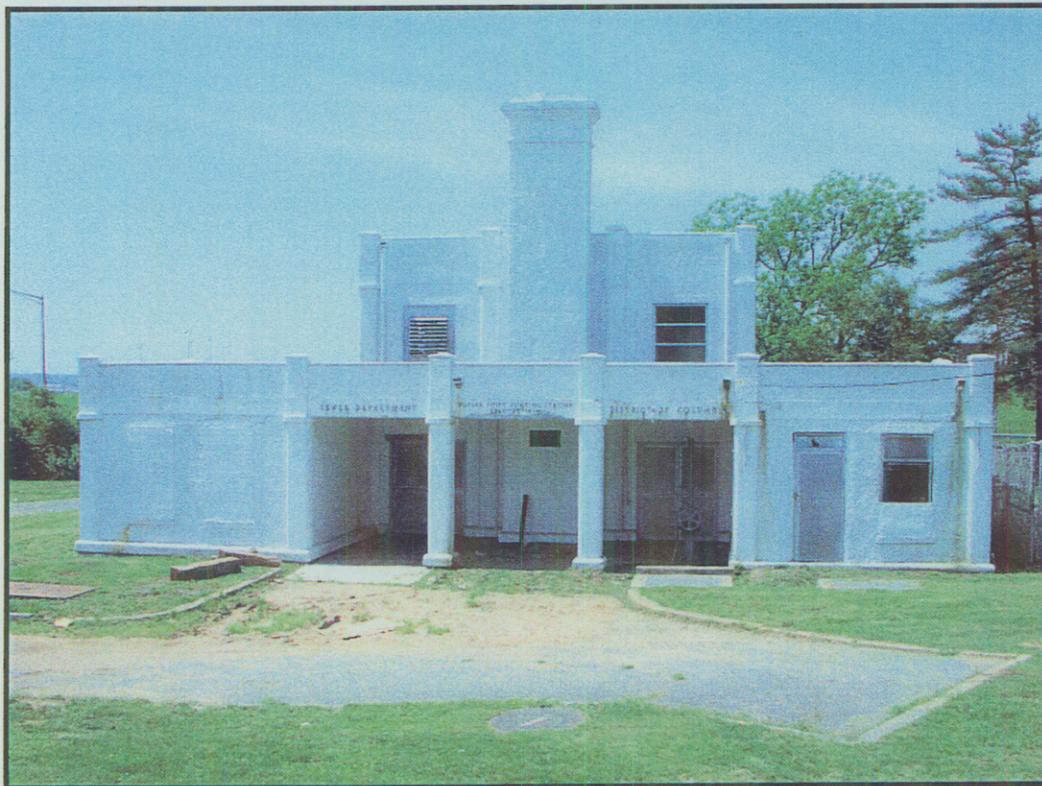
**Photo 10:** District of Columbia Poplar Point Sewage Pumping Station, facing west.

Five pad-mounted electrical transformers were observed near the northern portion of the District of Columbia Poplar Point Sanitary Sewer Pump Station, which adjoins 5861-945 to the west. No signs of staining were observed on the transformers or on the ground surface beneath the transformers. The transformers did not appear to represent a RECs in connection with the Project Study Area.
