## Request for Conditional Closure

**Site:** Polovina Hill stockpile, also known as non-Two Party Agreement (TPA) Site 47

Request for Conditional Closure  
Polovina Hill Stockpile, non-TPA Site 47  
St. Paul Island, Alaska

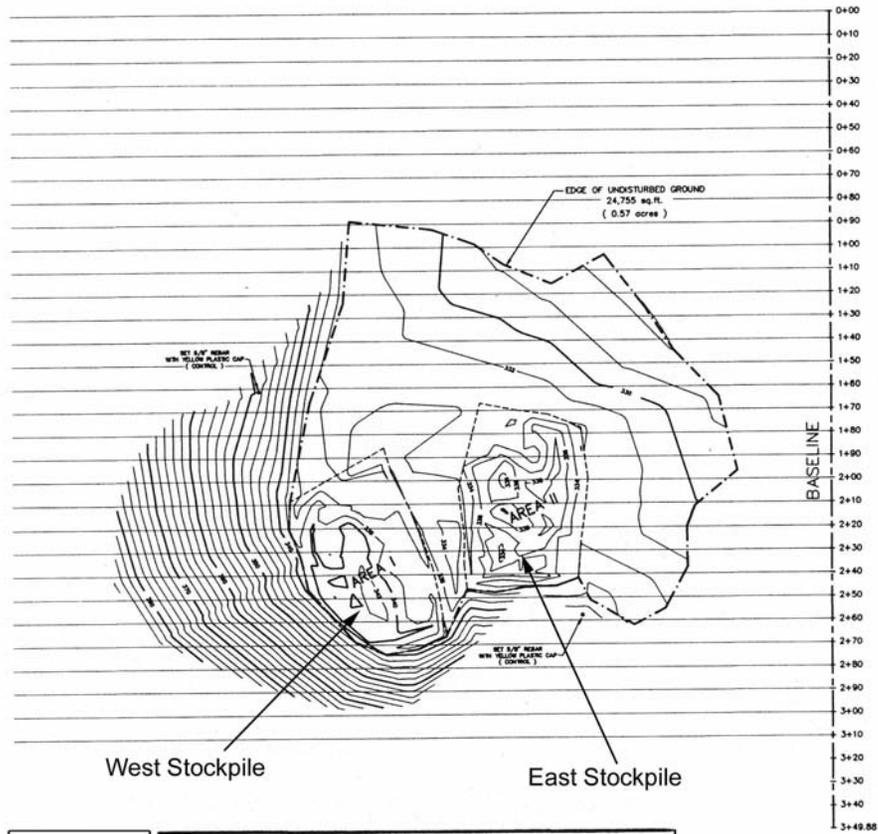
<b>Plan</b> <b>Polovina Pit Materials Survey</b> St. Paul Island, Alaska			
<b>SENTEC Inc.</b>			
SURVEY	ENGINEERING	PLANNING	
Ph. (907) 562-9966 Fax. (907) 562-9924			
4141 Ingra Street, Suite 201 Anchorage, AK 99503			
DRAWN: 480.DWG	H. SCALE: 1" = 20'	DATE: 8/8/97	SHEET
DRAWN: VTD	V. SCALE: N/A	W.O. NO. 97480	1 OF 3

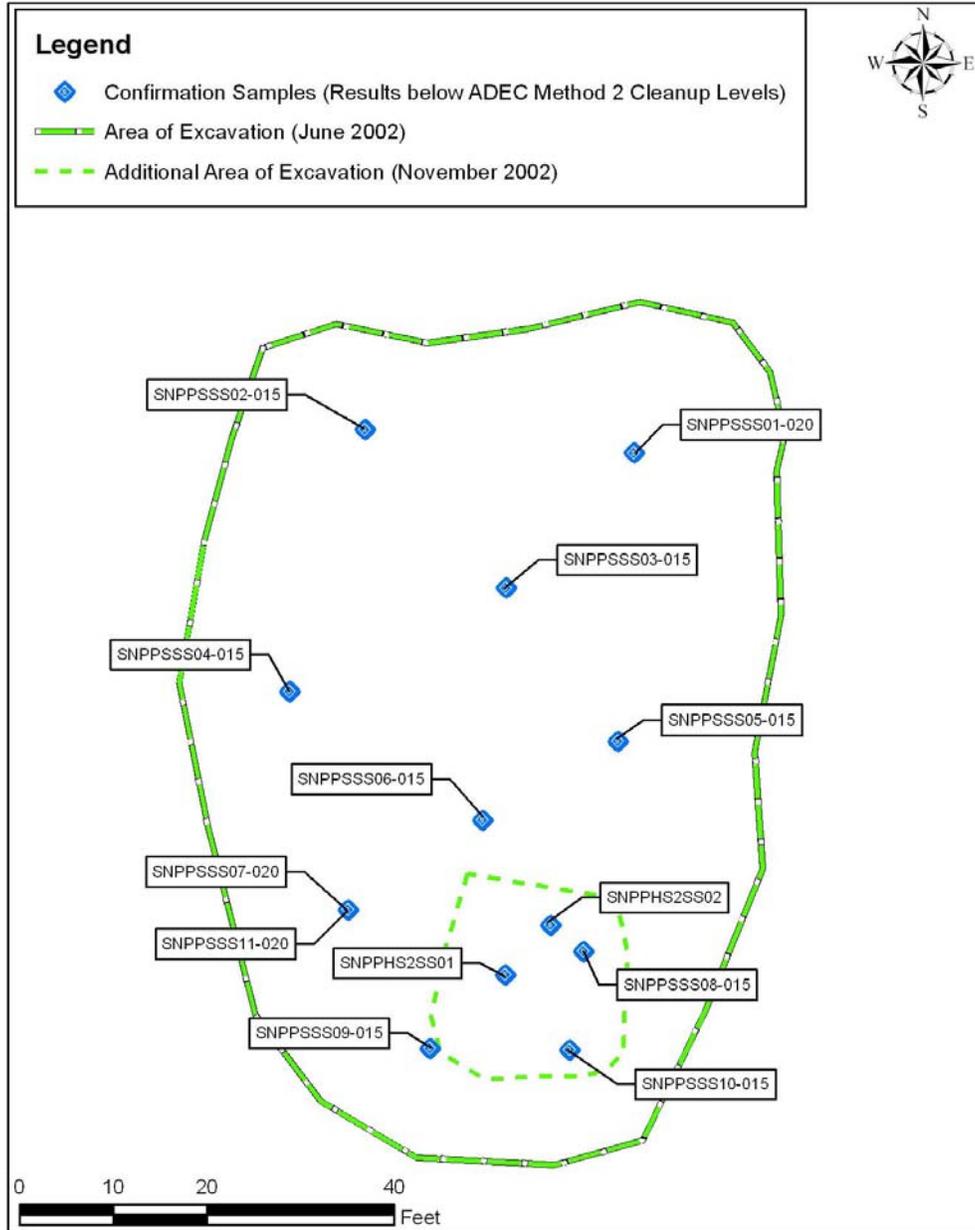
Figure  
4

Sampling Locations and Results  
Polovina Hill Stockpile Site  
St. Paul Island, Alaska

Samples were collected along a predetermined grid (Figure 4) and sent to a fixed-laboratory to verify that the stockpiled soils had not contaminated the site soils. BSE re-graded the stockpile footprint to match the surrounding ground surface (Photograph 3). This did not require the import of clean fill.

[Note: the receipt of erroneous duplicate analytical data for sample SNPPSSS08-015 resulted in removal of an additional 10 cubic yards of soil in the location of this sample (Figure 4). Following this additional removal, BSE collected two additional confirmation samples (SNPPHS2SS01 and SNPPHS2SS02) on November 4, 2002. Results of these samples were below cleanup levels. It was later determined that the additional soil removal and confirmation sampling had been superfluous. The sample found to be above cleanup level was related to another site and had been mistakenly included in sampling results for this site.]

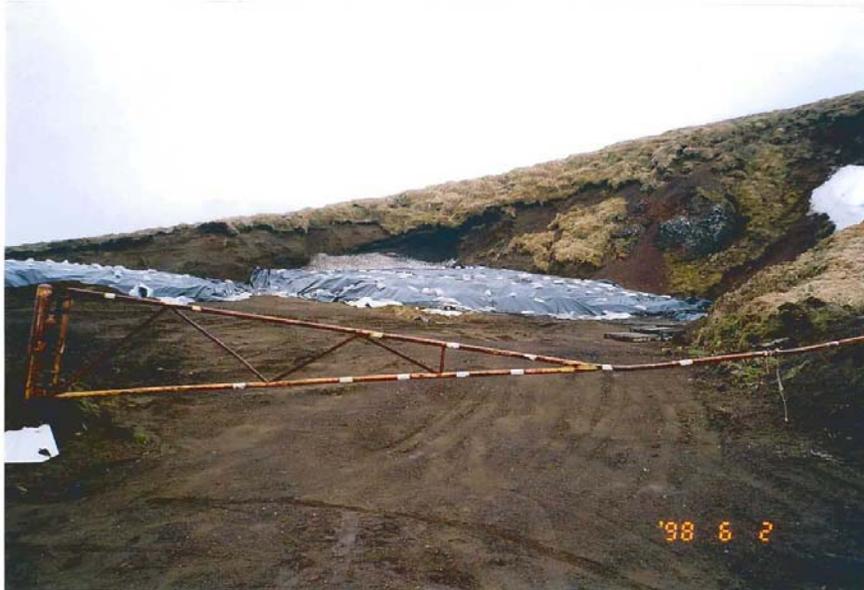
**Photograph 1.** Stockpiled soils at Polovina Hill segregated according to type of contamination (*i.e.*, diesel or gasoline).

During 1997, NOAA and its contractors removed underground storage tanks (USTs) from the former gas station, the decommissioned power plant, and the municipal garage on St. Paul Island. Petroleum-contaminated soils (PCS) from UST removal actions were stockpiled for long-term storage at an excavation on the slope of Polovina Hill. Stockpiled soils were segregated according to the type of contamination. Soil categorized as diesel-contaminated comprised a west stockpile, while soil categorized as gasoline-contaminated comprised an east stockpile (Figure 3; Photograph 1). NOAA constructed the stockpiles in accordance with Alaska Department of Environmental Conservation (ADEC) standards for long-term stockpiling (ADEC 1991). The soils were placed on a bottom liner and covered with a second liner (Photographs 1 and 2).

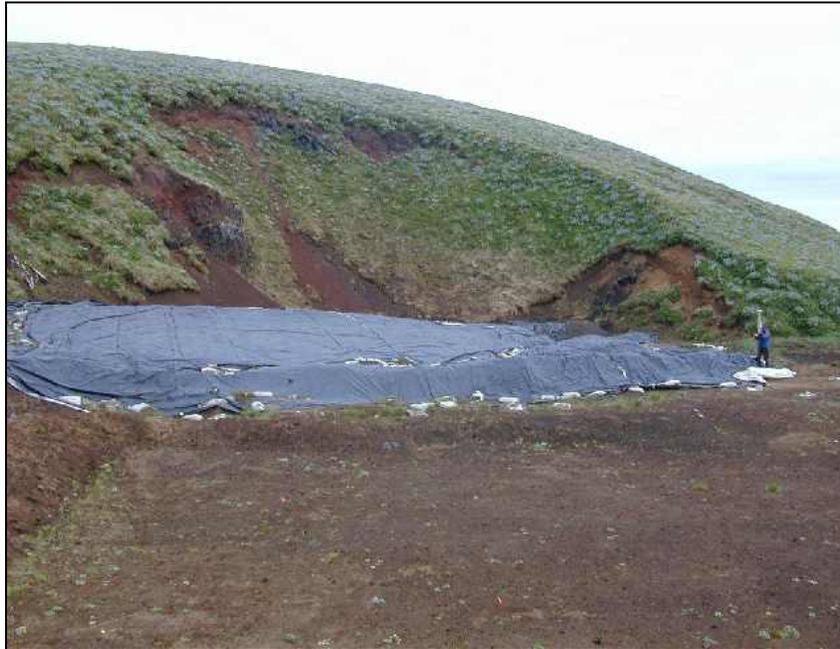
**Photograph 2.** Polovina Hill petroleum-contaminated soil stockpile in 2002 prior to removal.

Bering Sea Eccotech (BSE) removed the west stockpile from the Polovina Hill site on July 8-10, 2002 (NOAA 2005a). BSE transported approximately 400 cubic yards of PCS to the Blubber Dump stockpile site to await thermal treatment. Subsequently, NOAA and BSE thermally treated the soil in NOAA's ETC system. Following treatment, NOAA collected samples to confirm that the treatment lowered contaminant levels to acceptable concentrations prior to the soil's beneficial reuse at the St. Paul landfill (NOAA 2005b).

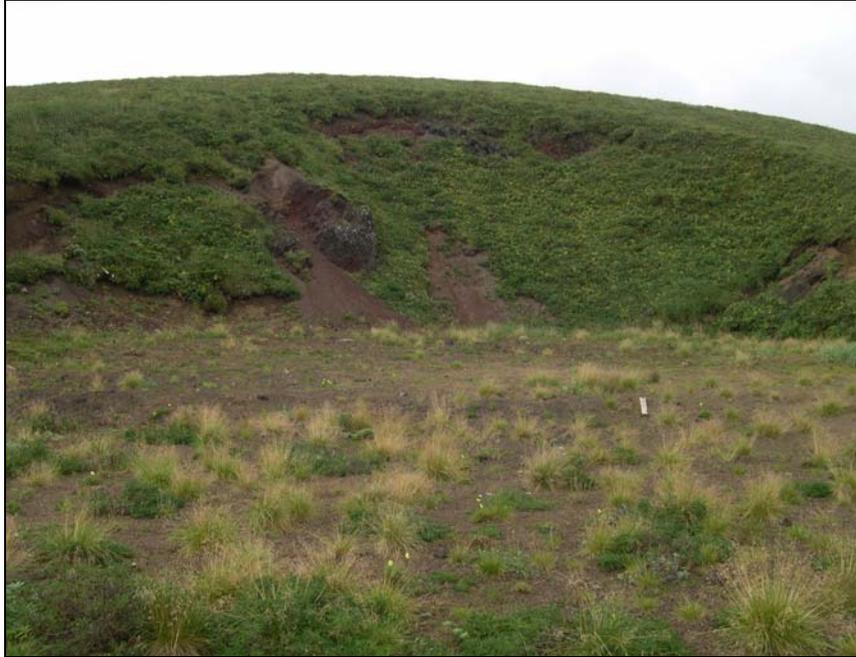
**Photograph 3.** Polovina Hill stockpile site after cleanup actions (2003).
