PRIBILOF ISLANDS DEC. 2004 RAB:

Pribilof Islands Restoration Project

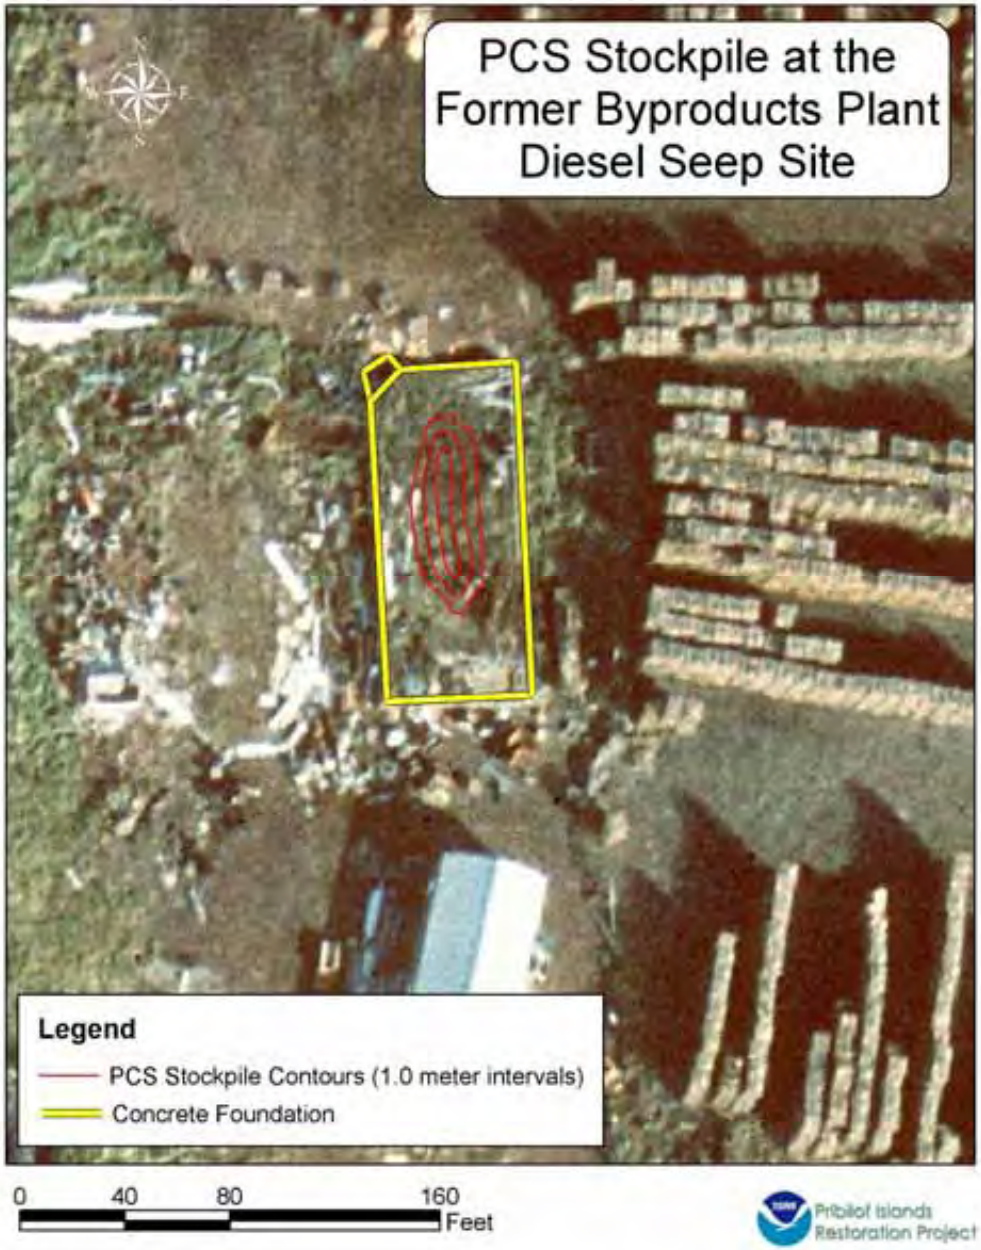
Diesel Seep: –Foundation PCS Pile

752 cy removed
Drum Pad Confirmation Samples
